Typical damage to labyrinth fins.

Ill. 3.1.2.4-7.1: Characteristic, load-specific damage symptoms in labyrinth fins:

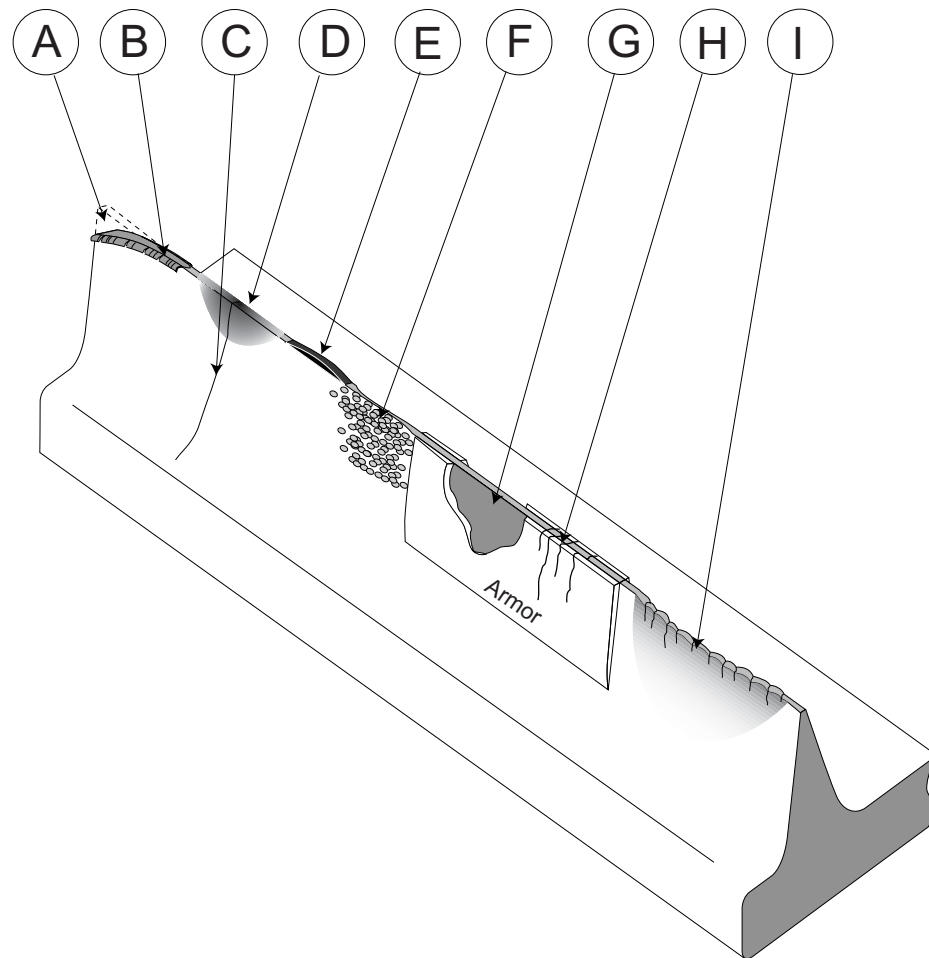
Ill. 3.1.2.4-7.1

The depth of the wear and the circumferential length of the wear zone depend on the **radial infeed motion**. Infeed is caused by local distortion, shaft deflection, imbalances, or vibrations. Wear can occur along the entire circumference or only in a limited area. Typical symptoms in a rubbing zone are **burring** ("B") and tarnishing or increased oxidation. These

characteristics also indicate damaged sections of material (e.g., decreased hardness/strength; "D"). If the grain boundaries in these zones soften or melt, even small tensile stress can cause **hot cracks**. These cracks occur individually or in crack fields (see also "H"). They advance ("C") due to sufficiently high LCF- (thermal fatigue) or HCF-loads (labyrinth vibrations). If material deposits remain on the fin (**smear**ed "E"), they can increase the rubbing process to dangerous levels (Ill. 3.1.2.4-6).

Erosion particles in the shape of **spalled rub coatings** or removed material put erosive stress on the fins (“F”). The symptoms of this are similar to “**peppering**” (the impact points of the individual particles are still recognizable).

Spalling or local delamination of **hard-material armor** (e.g. Al_2O_3) is a common type of damage (“G”) and should be considered in connection with **manufacturing flaws** and/or **handling mistakes** (transport, mounting).

Not even armoring provides absolute protection against hot cracks (“H”). This is especially true if the armor is **not sufficiently cuttable** (which may be indicated by the coating roughness) which causes too much heat to be created in the rubbing zone (also see “C”).

The labyrinth fin materials that, for example, are exposed to the hot gas flow due to the leakage air in the turbine area, must be **sufficiently resistant to oxidation**. In oxidation-sensitive, highly heat-resistant materials or unsuitable welded deposits, **oxidation damages** have been observed that are similar to the orange-peel effect on the intake edges of overheated turbine blades (“I”). A typical symptom are many small cracks due to thermal fatigue caused by start-up/shut-down cycles.

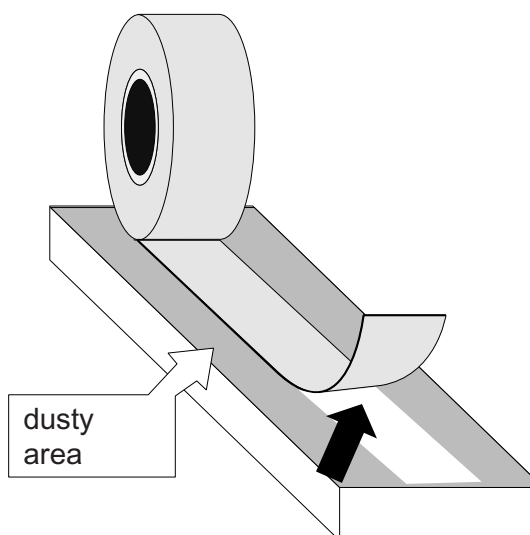
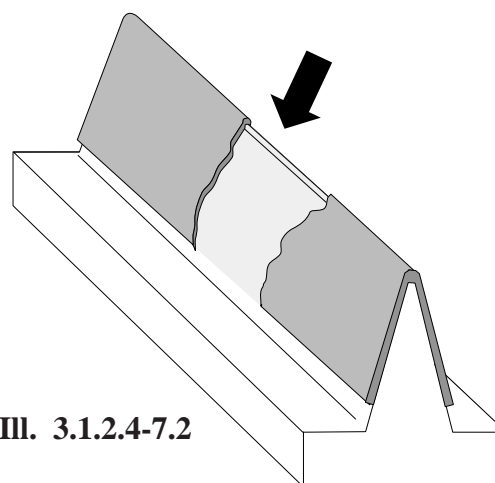
Ill. 3.1.2.4-7.2

Ill. 3.1.2.4-7.2: The „bead problem“. This is a matter of a frequent **production caused** problem dealing with **debonding** respectively **breake outs** of **thermal sprayed coatings**. The effect is similar to the mechanism that accounts for a poor adherence of adhesive strips on a **dusty surface**. Lay **ricocheted** small solidified molten drops from the thermal spray process on the to be coated surface, the bonding strength suffers enormous. When failures of thermal sprayed coatings occur first of all is to look (scanning electronic microscope = SEM) at the debonding surface if such agglomerations of „**splash beads**“ exist.

Dust is the enemy for the adherence strength of thermal spray coatings.

out-broken hard face coating of a labyrinth tip
