Ill. 4.1-7: Some typical pictures of *high pressure turbine blades*, as the examiner views in the *borescope*, are represented as examples (see also *Lit.4.1-4* and *Lit. 4.1-5*).

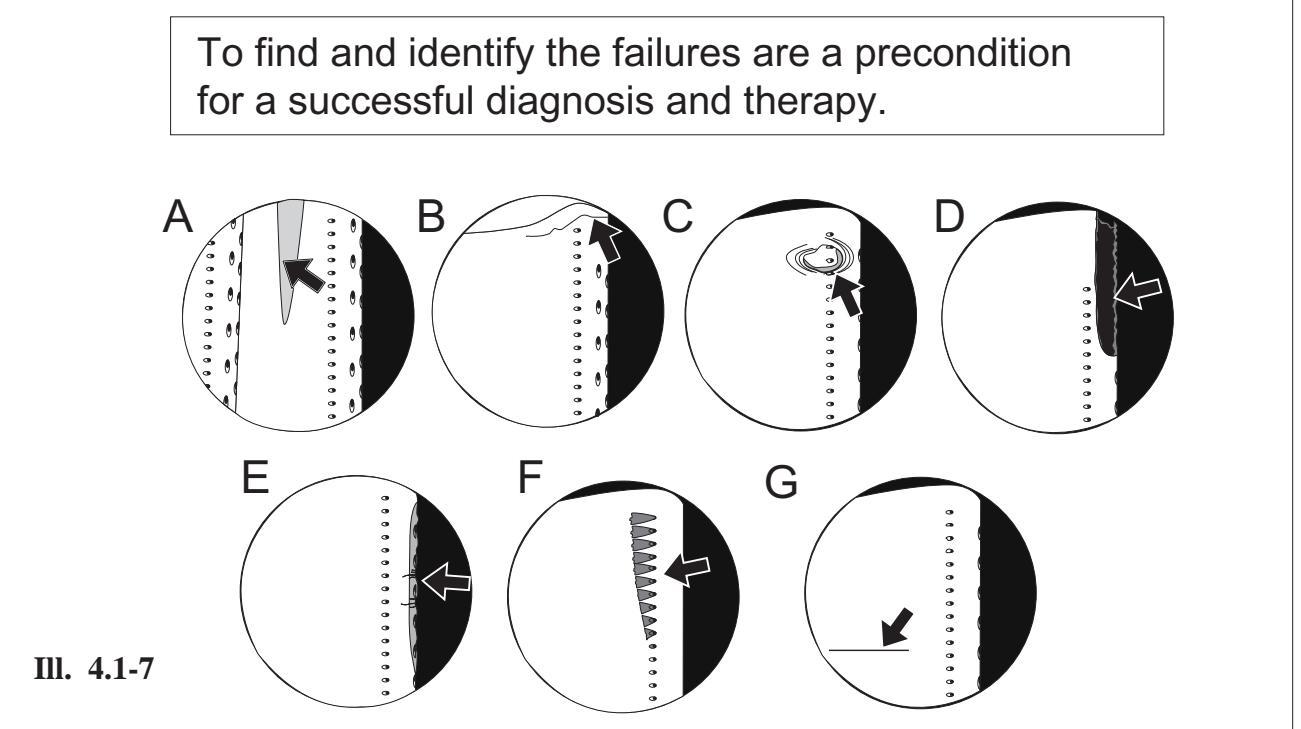
"A": Local oxidation damage, also in connection with hot gas corrosion, in the area of a component specific hot spot, where the film cooling air is insufficiently effective. The protective diffusion coating is here already consumed, the base material becomes visible.

"B": Typical **thermal fatigue crack** with delayed crack growth (Ill. 3.3-9) on one guide vane in the **transition to the outer shroud**.

"C": OOD (Impact through internal foreign objects) on a rotor blade (secondary failure see "D" in Ill. 3.3-10). Typical for the turbine is the area on the suction side of the leading edge region. Foreign objects in the high pressure turbine are, e.g., coke particles from the combustor (carbon impact) or released ceramic particles from the thermal barriers (Ill. 3.2.3-4). "D": Burnt leading edge ("E") in the tip region of a turbine rotor blade without shroud. Cause of the over temperature can be an inner blockage of the cooling air hole (e.g., a closed dust removal opening) or a narrowing of the cooling air hole, as a consequence of a deformation (OOD, "C").

"E": Heavy oxidation (burning) and thermal fatigue cracks on the leading edge of a turbine blade. This typical appearance at local over temperatures is also called the orange peel effect.

"F": Turbine rotor blades from which foreign material, e.g., **labyrinth or abradable abrasions** from the compressor (Ill. 3.1.2.4-4), emerges out of the film cooling holes and melt.

"G": Black line on direction of the flow can originate from coked oil and is in this case not dangerous. But if it is a matter of an internal crack, originated from the cooling structure of the blade (Ill. 4.1-5) a fracture of the blade must be expected.
