External Factors Weather: Ice

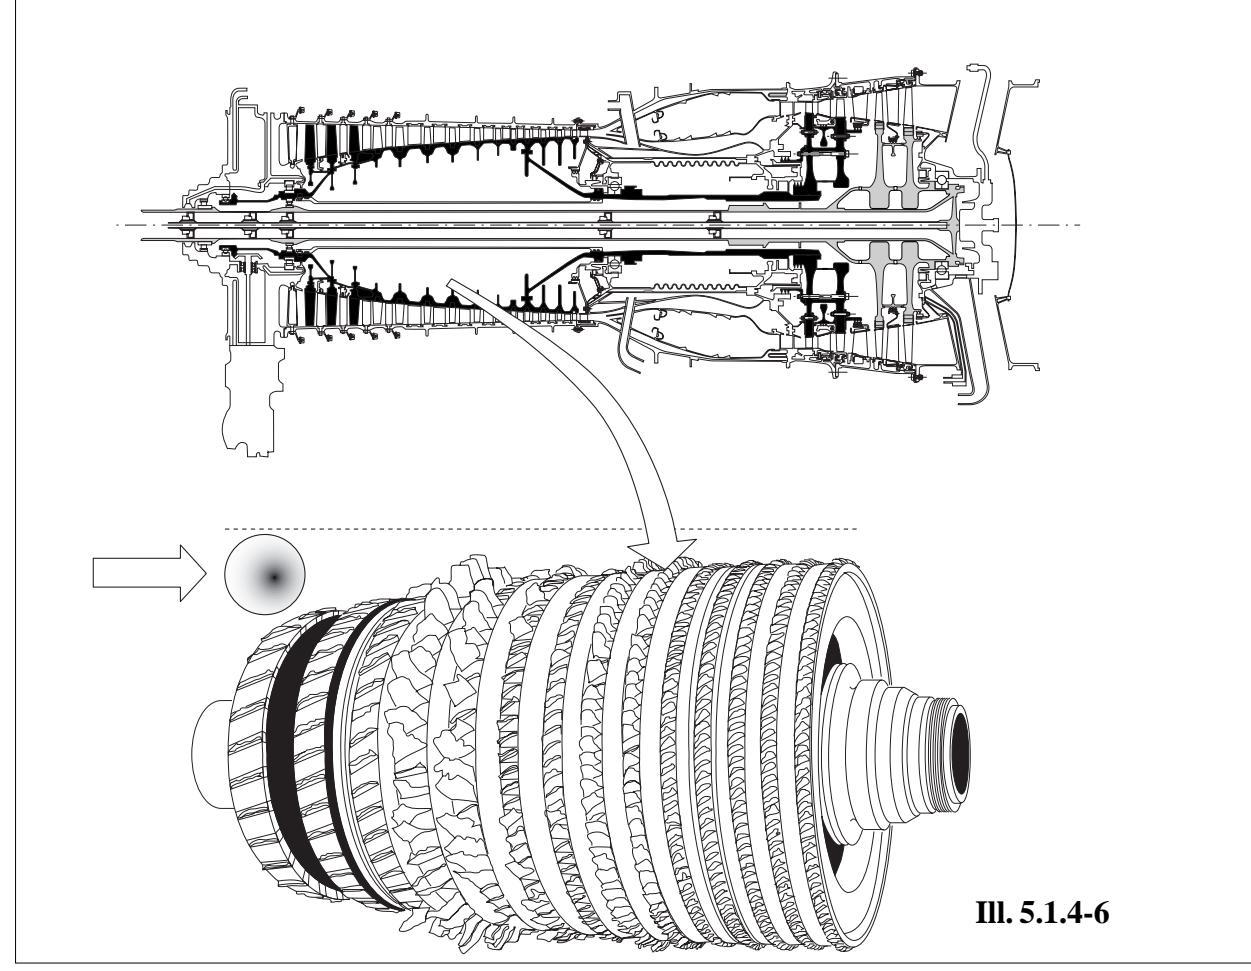
Illustration 5.1.4-6: This diagram shows a 2500 kW helicopter engine (from Ill. 5.1.4-5) after a heavy ice strike. All the rotor blades are mostly destroyed. The sudden relaxation of the combustion chamber blew the fragments forward and most of them lay in the engine inlet.

A hand-formed snowball with a diameter of about 10 cm can be enough to cause extensive damages in smaller engines.

Similar damage was reproduced in a test by throwing a handmade snowball with about 10 cm diameter into the running engine.

The relatively filigreed structure of the compressor blading, the front section of which is made of titanium alloy, makes it even more vulnerable to this type of damage. Less damage would be likely occur in a radial compressor due to its more robust blading.
